Spirit of St Louis Replica (Ryan M1/M2 NYP), ES-XCL

AAIB Bulletin No: 1/2004	Ref: EW/C2003/05/05	Category: 1.3
Aircraft Type and Registration:	Spirit of St Louis Replica (Ryan M1/M2 NYP), ES-XCL	
No & Type of Engines:	1 Continental W670-6A piston engine	
Year of Manufacture:	1997	
Date & Time (UTC):	31 May 2003 at 1650 hrs	
Location:	Coventry Airfield, West Midlands	
Type of Flight:	Private	
Persons on Board:	Crew - 1	Passengers - None
Injuries:	Crew - 1 (Fatal)	Passengers - N/A
Nature of Damage:	Aircraft destroyed	
Commander's Licence:	Air Transport Pilot's Licence	
Commander's Age:	59 years	
Commander's Flying Experience:	21,200 hours (of which 190 were on type)	
	Last 90 days - 89 hours	
	Last 28 days - 18 hours	
Information Source:	AAIB Field Investigation

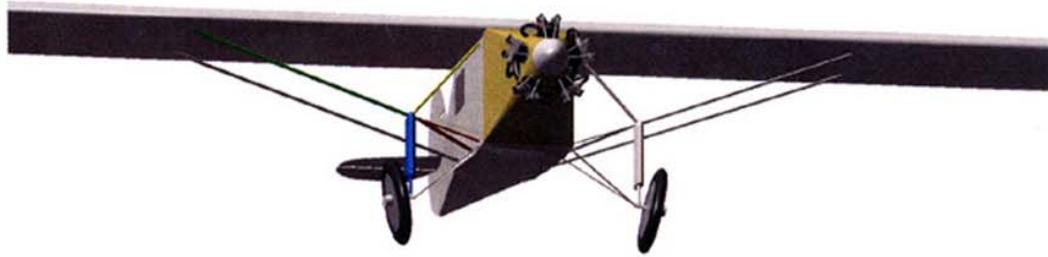
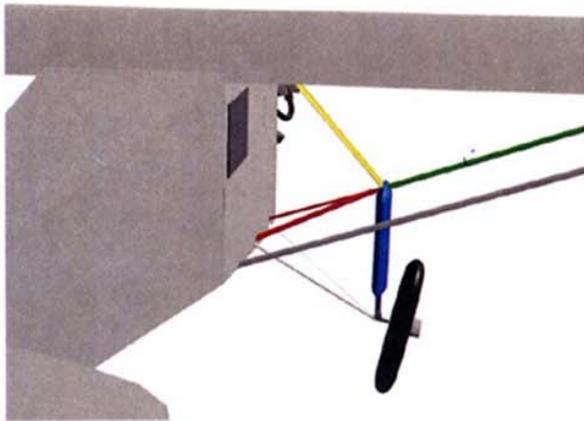
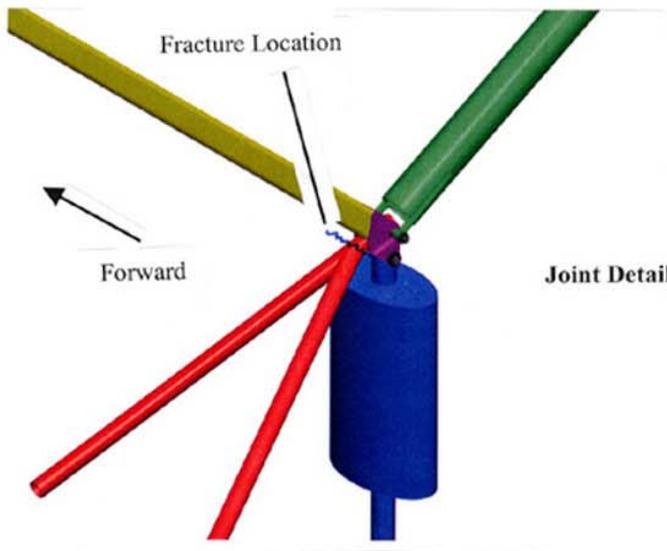
Figure 1: Landing Gear and Wing Strut Support Structure

A tubular steel wishbone strut, mounted from the lower edge of the fuselage and braced to the upper edge, locates and supports both the upper end of the right landing gear shock-strut and the lower end of the forward right wing strut, Figure 1. The wishbone comprises a main strut (the forward leg of the wishbone) of 1.25" outside diameter (OD) steel tube and 0.0625" wall thickness, and a diagonal bracing strut (the rear leg) of 1.0625" OD steel tube and 0.0625" wall thickness. These are welded together at their apex, but the forward leg extends outboard slightly beyond the apex joint, where it is welded to the bracing tube connecting to the top of the fuselage frame. This joint is stiffened and braced by a pair of steel 'fish-plates' welded on either side of the wishbone strut main tube and the fuselage bracing tube, and this also forms, in effect, a pair of locating sockets for the top of the landing gear strut and bottom of the wing lift strut.

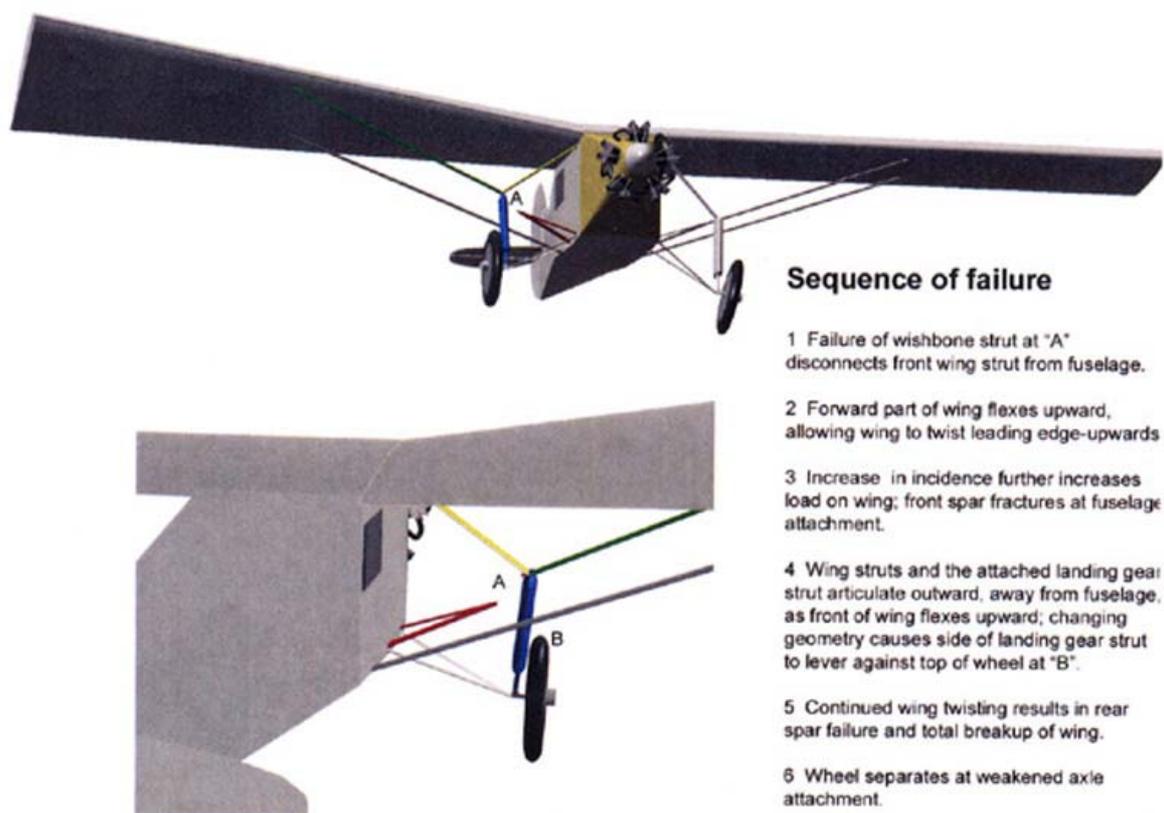
Figure 2: Sequence of failure

A detailed examination of the wreckage, in situ, quickly established that the outboard end of the tubular wishbone strut had failed in flight as a result of a fatigue crack. Initial examination revealed that the crack extended through approximately 90% of the cross-section area and that surface corrosion was evident over much of the fatigue crack fracture surface. The final 10% of the fracture surface, which exhibited characteristics consistent with a tensile overload mode of failure, was clean. The geometry of the external bracing struts on the 'Spirit of St Louis' design is such that the fatigue failure of the wishbone strut would effectively dislocate the lower end of the right wing forward lift strut, which supports the right wing front spar. This would allow the lower end of the lift strut, together with the top end of the right landing gear shock strut, to articulate upward and outward. The expected outcome would be the immediate overload failure of the front spar at its root end, ie, the point of maximum bending moment, followed immediately by break-up of the remaining inboard wing structure. The inboard part of the rear spar would also be expected to fail due to the consequent upward and rearward twisting of the wing, Figure 2.

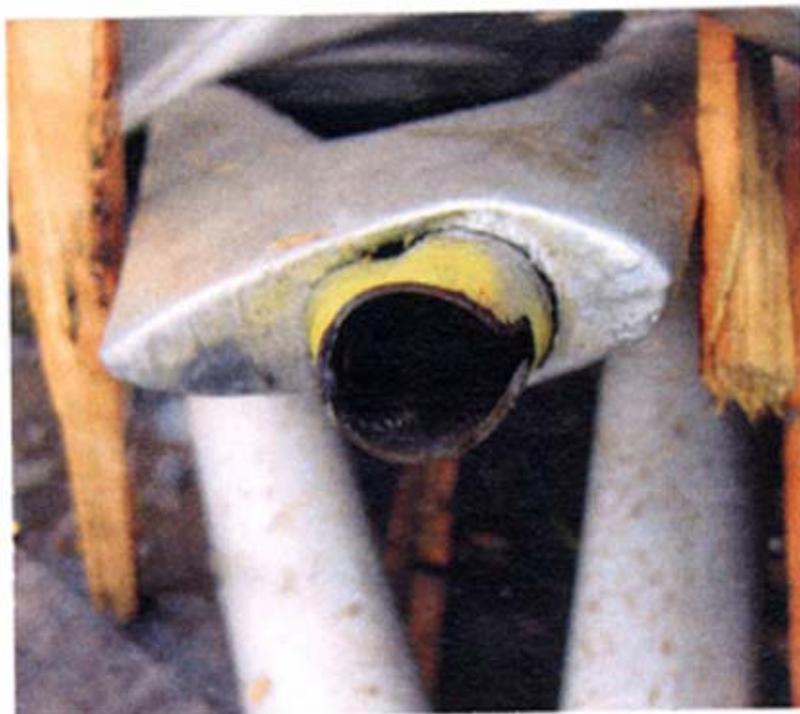
Figure 3: Fractured end of right wishbone strut

Inspection of the fracture surface using a hand lens suggested that the fatigue crack originated in a region of weld forming part of a joint, connecting the two tubes of the strut at its apex. It was also noted that the part of the strut containing this welded joint which lay beyond the outer ends of the aerofoil shaped fairings covering the two strut members and was thus fully exposed, had been oversprayed with a yellow 'chromate primer' type of paint. This paint was of a different colour to the paint used elsewhere on the tubular framework of the aircraft and had evidently been applied after the aircraft had been built, Figure 3.

View on fractured end of right wishbone strut showing evidence of 'fresh' chromate primer type paint around weld area

The external appearance of the weld local to the fracture initiation was out of character with the remainder of the tube-to-tube weld, which indicated that re-welding of this area had been carried out after initial manufacture. Microsections through this region confirmed that capping deposits were present and that high temperatures had been achieved, producing large grain sizes in the microstructure at the surface. However, grain refinement had occurred in what appeared to be the original burnt-through weld deposit, and the alignment of this deposit appeared to be poor relative to the tube being attached. The sections showed the presence of oxide films which reduced the effective material thickness, locally, to about 76% of the original tube.

In summary, the area of re-welding in which the fatigue crack had originated was of poor quality, and this was probably exacerbated by inadequate preparation. In contrast, based on the limited samples examined, the overall quality of the original welding of the wishbone strut (and by implication of the tubular fuselage structure generally) appeared to have been high.

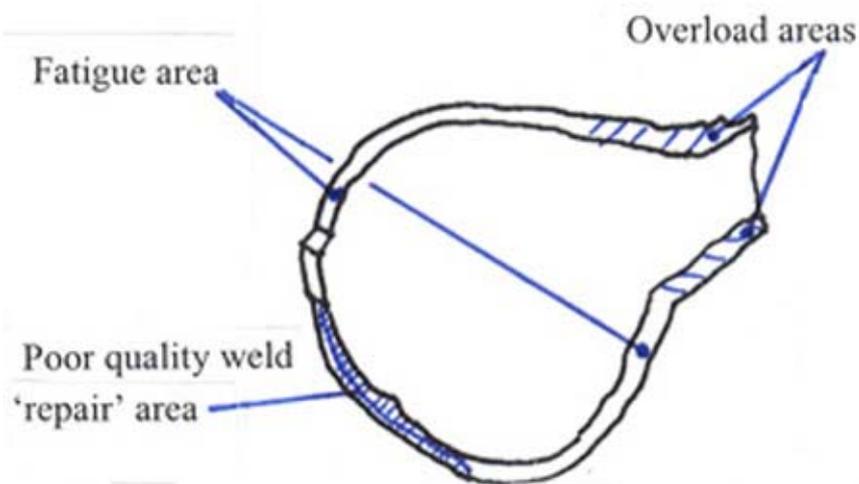
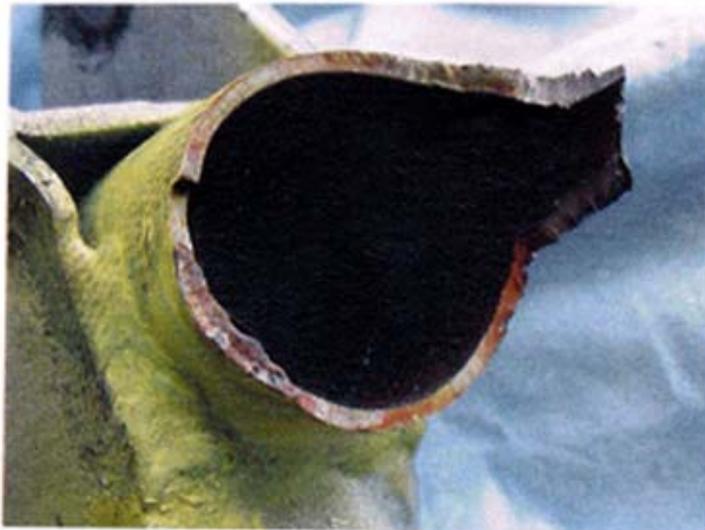
Figure 4: Detail of fatigue crack / overload fracture surface

The fatigue crack had originated at the apex of a weld in the wishbone, at the joint between the two legs of the wishbone and evidence was found of multiple fatigue initiations at the mid-wall of the tube, inboard of the toe of the weld. The weld metal behind these multiple initiations contained a large number of slag inclusions, porosity due to shrinkage and gas inclusion, and oxide films, the presence of which would have seriously reduced the load bearing capacity of this part of the tube and provided potent stress concentrating features.

The fatigue crack, Figure 4, had propagated initially in a radial direction, towards the outer surface of the tube and across the width of the welded region. Thereafter, two crack fronts had continued to propagate independently of one another, each by a fatigue mechanism, traveling circumferentially around the tube wall for about 75% of the circumference, in a plane normal to the tube axis. At this point, the fractures turned and grew longitudinally until final overload failure occurred through the remaining approximate 10% of the section, at 45° to the tube axis in both planes.

Detail of fatigue crack/overload fracture surface

The fatigue fracture was characterised by beach marks, with intervening bands of fine striations having a spacing which was often of less than one micron. The numbers of beach marks in the various regions of the fracture were estimated using optical microscopy, and the following results obtained:
